REPORT NO. CASD/LVP 78-078  
CONTRACT NAS 3-20644

## ATLAS 5013 TANK CORROSION TEST

# ATLAS 5013 TANK CORROSION TEST

December 1978

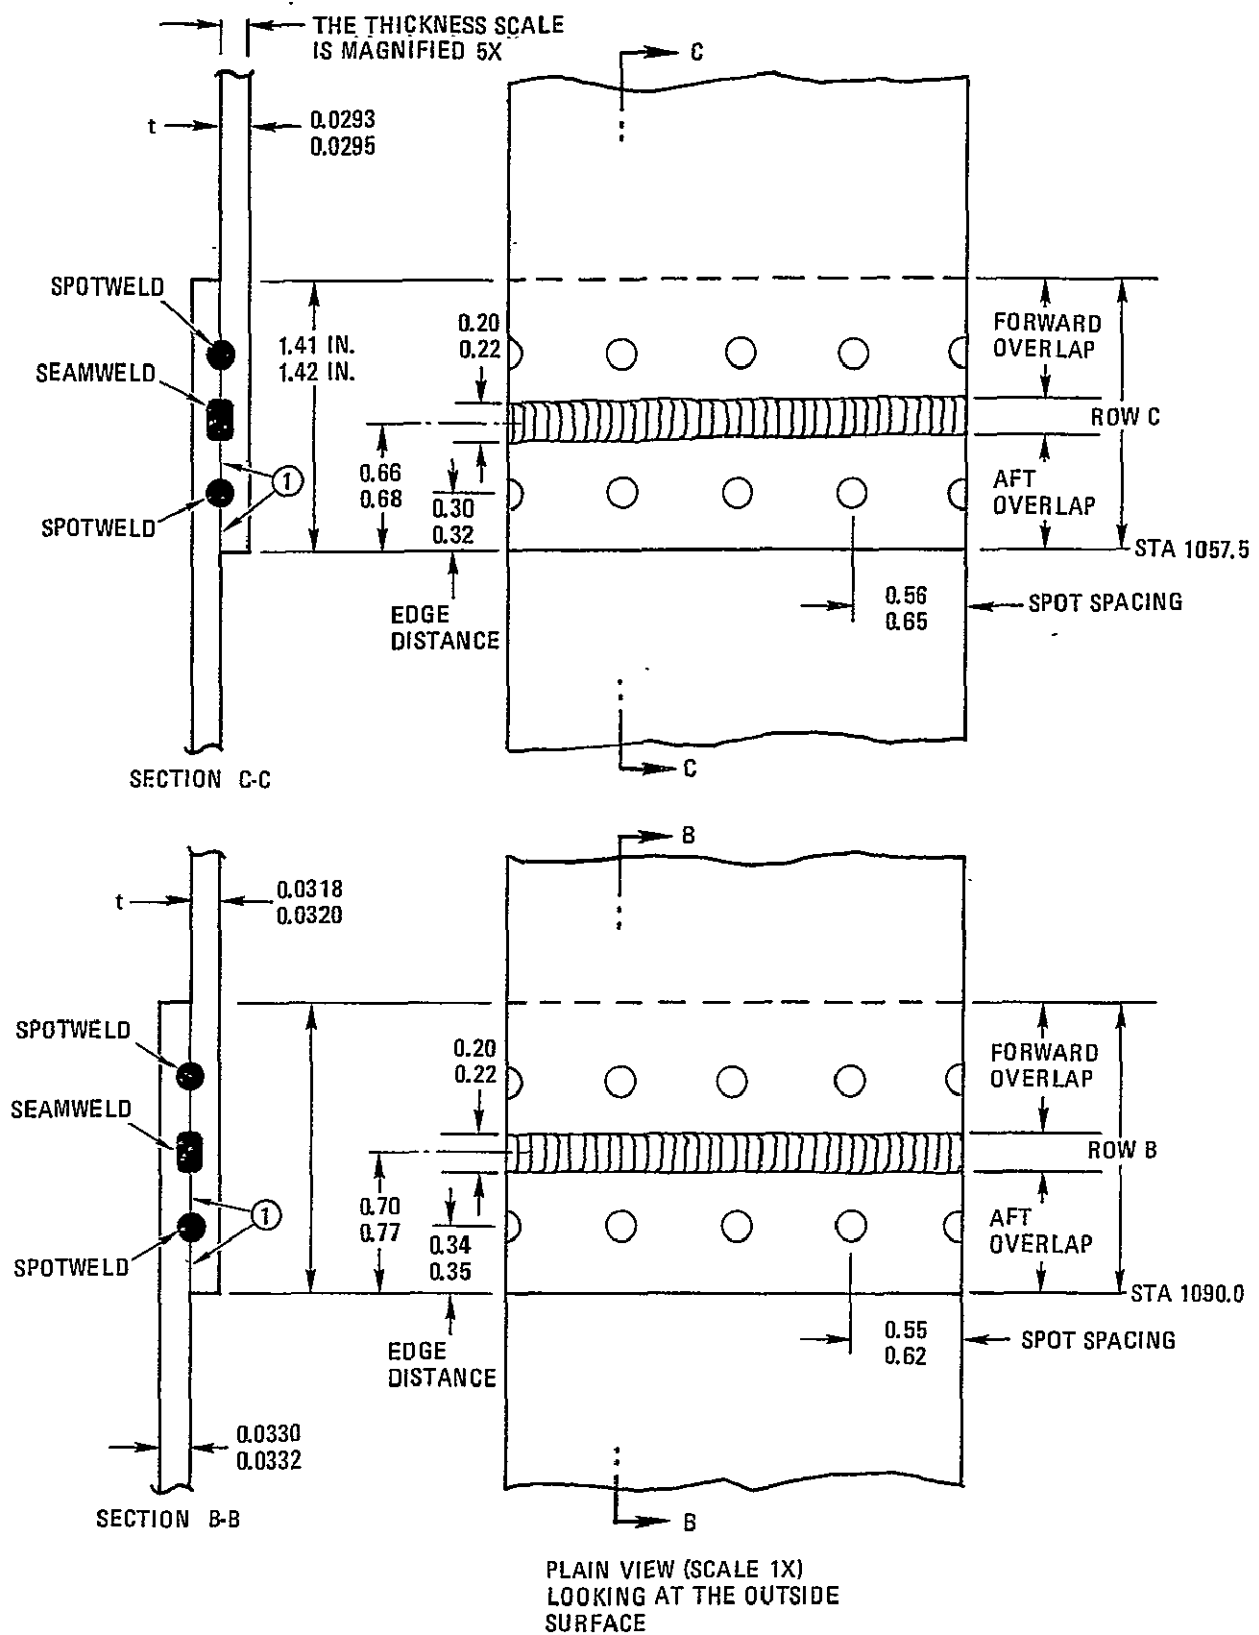
65343-41

① CORROSION AND STRESS CORROSION CRACKING INITIATED AT THE AFT INTERFACE

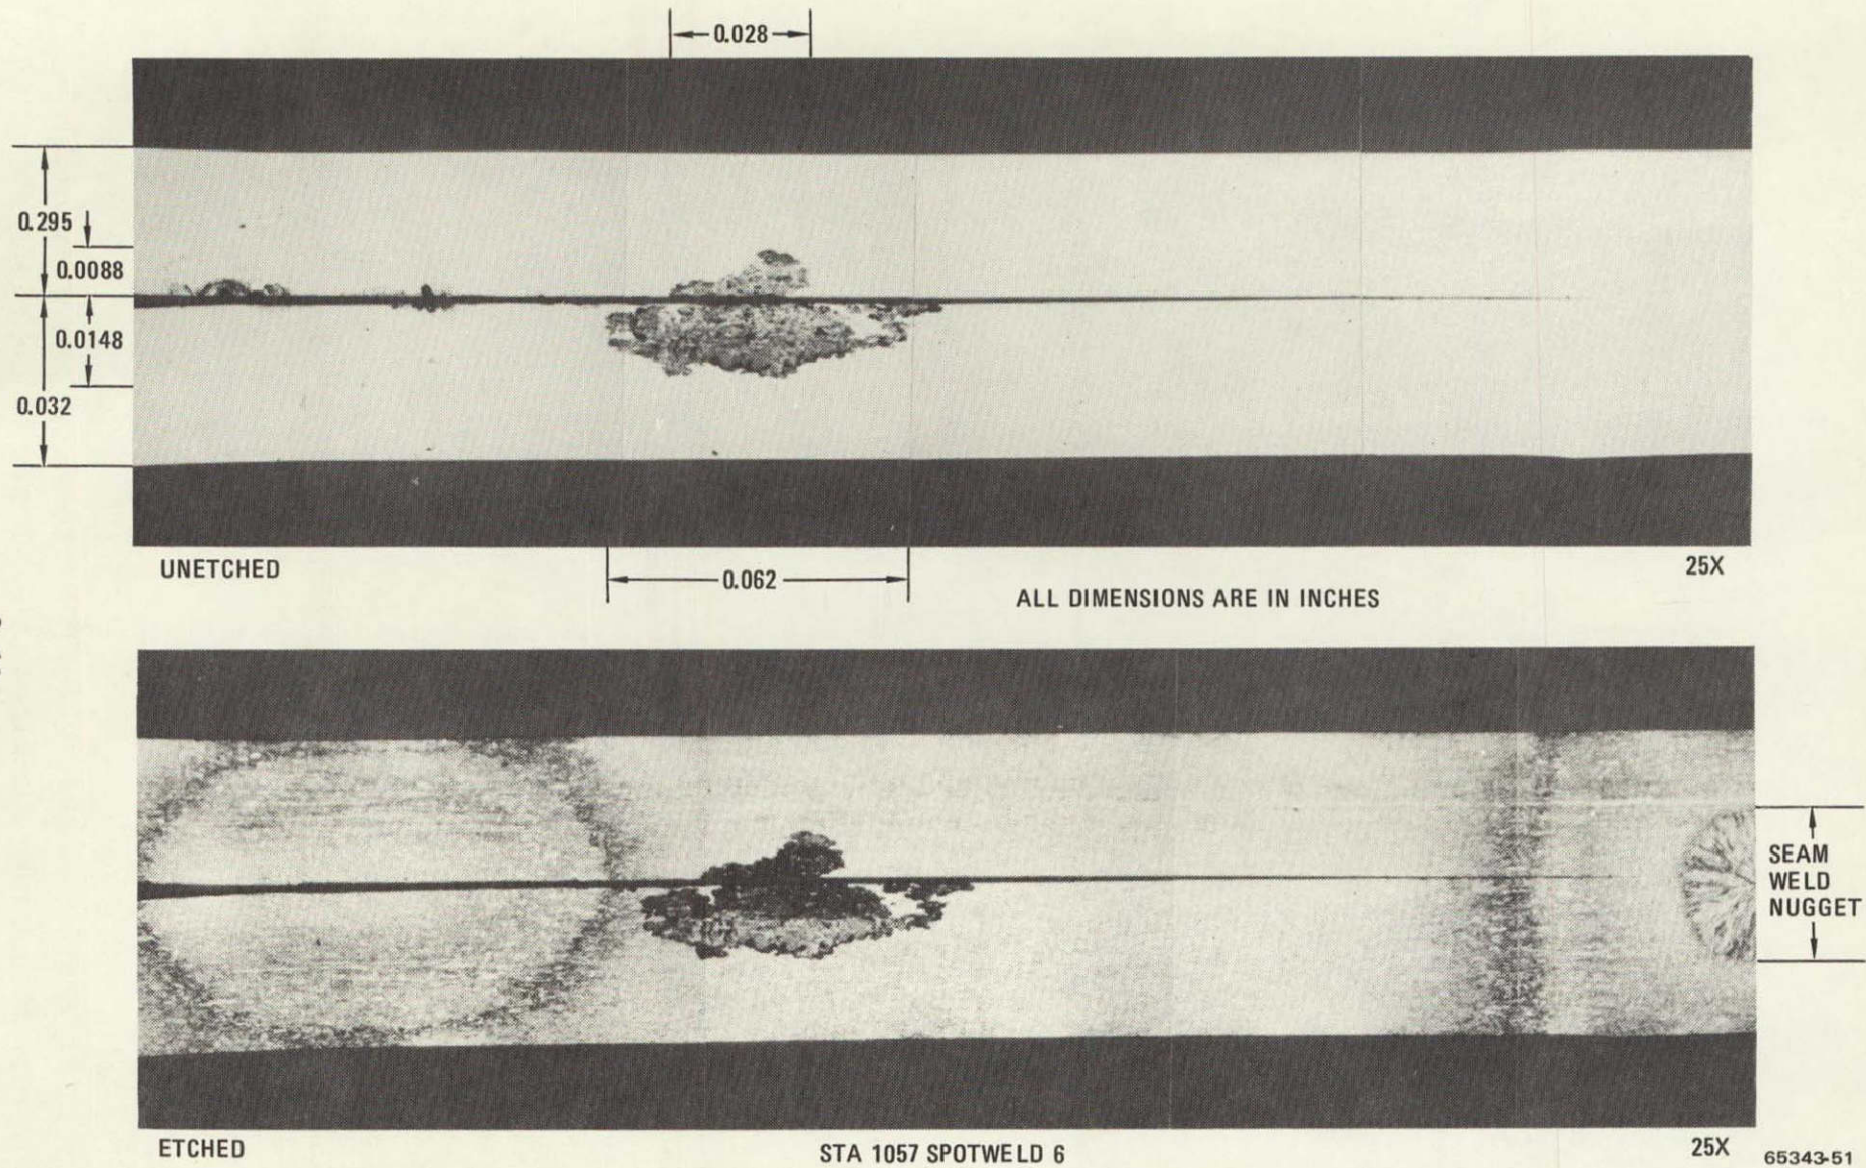
Figure 2-10. Appearance of Section (A-A) Through the Round, Pit-type Defect Indication Shown in Figure 2-9.

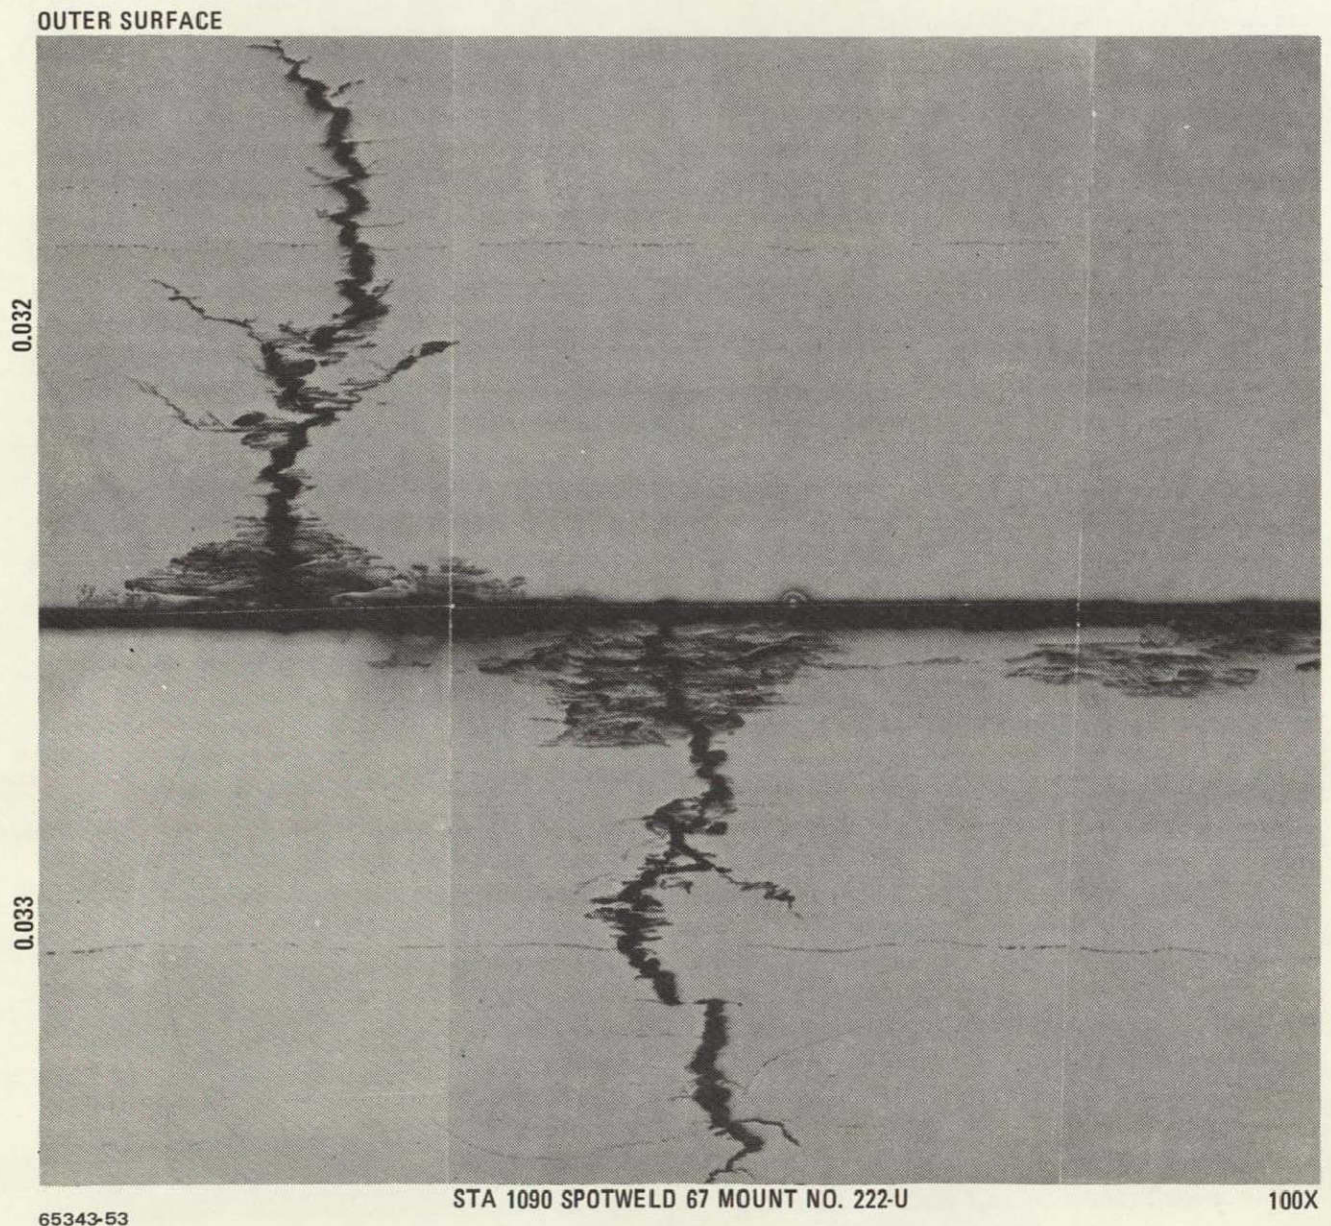
Figure 2-12. Unetched Appearance of Section A-A Through the Crack-type Defect Indications Shown in Figure 2-11

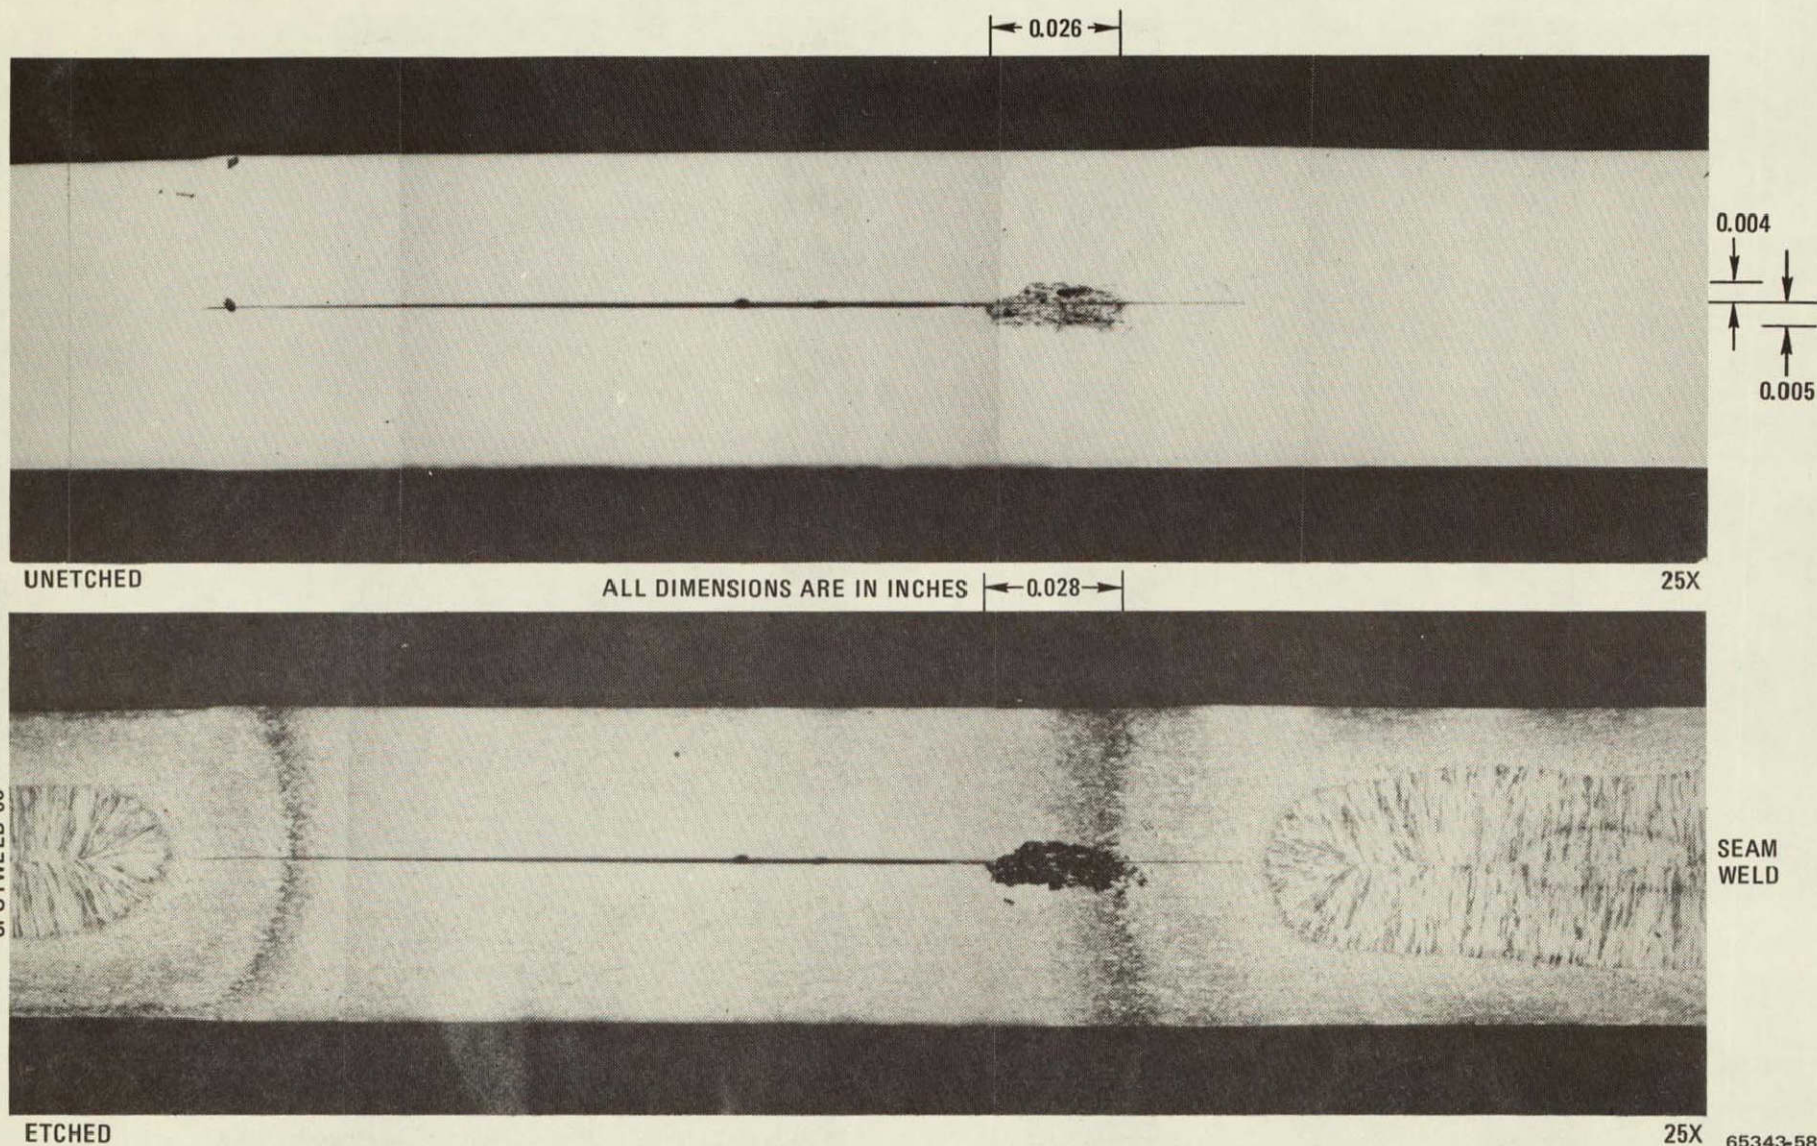
Figure 2-17. Appearance of Section A-A Through the Horizontal, "Length" Defect Indication Shown in Figure 2-16. The Magnification Reveals that the X-ray Indication was Produced by Interface Pitting-type Corrosion Attack Near and in the Weld-Carbide-Precipitation Zone

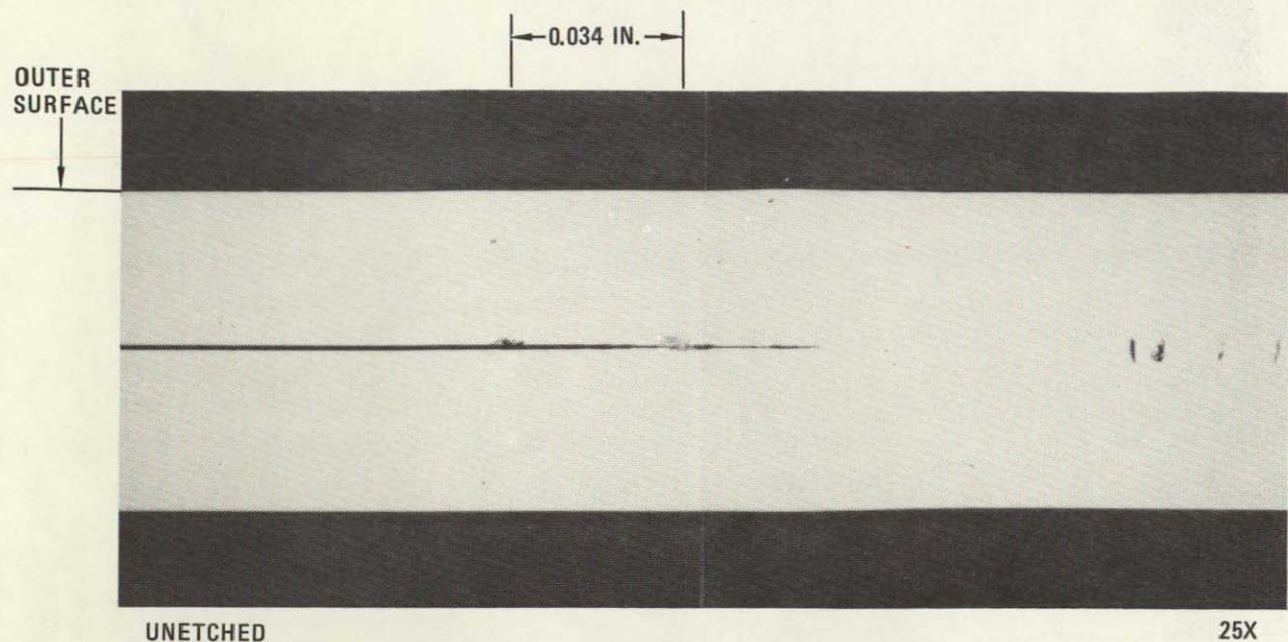
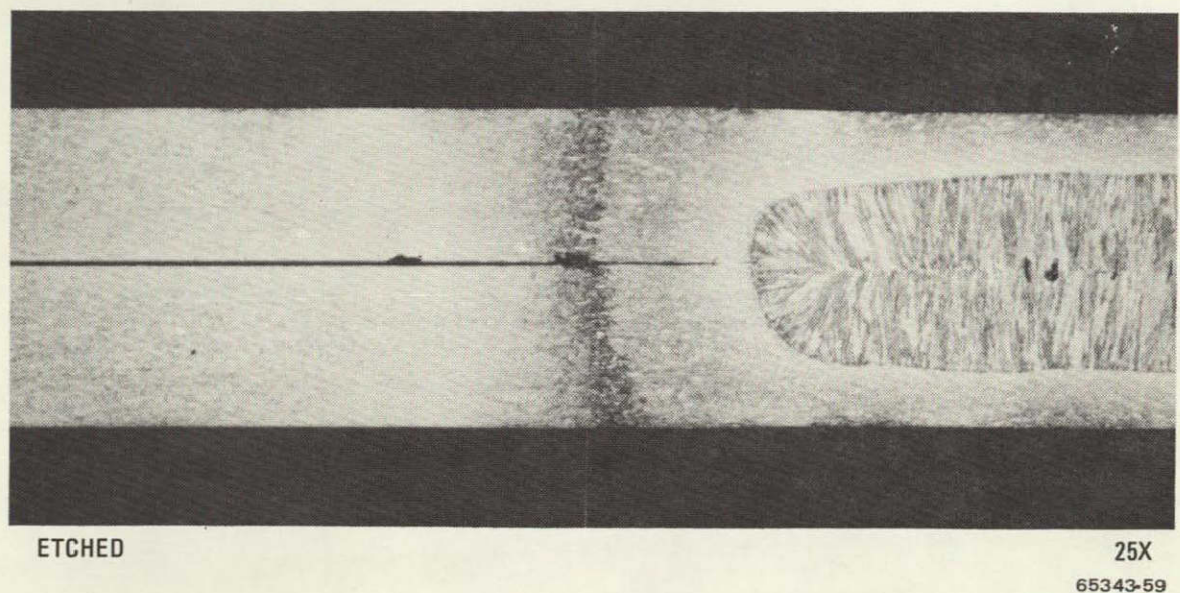
Figure 2-18. Appearance of Section B-B Through the Horizontal, "Length" Defect Indication Shown in Figure 2-16. The Defect in the Weld-Carbide-Precipitation Zone is Shown at Higher Magnification (300X) in Figure 2-19. This Section is 0.035 Inch from Section A-A

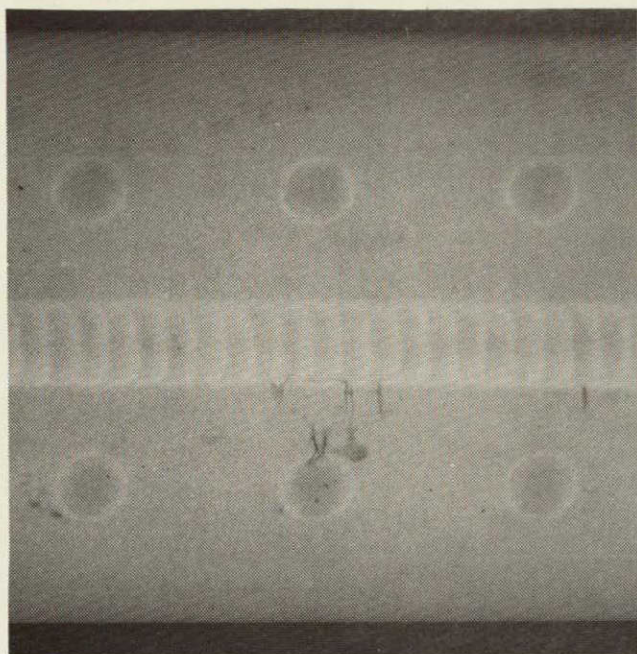
Figure 2-30. Same Areas Shown in Figure 2-29 after Etching. The Etching Broadens and Accentuates the Branching Stress Corrosion Cracks Emanating from the Faying Surface

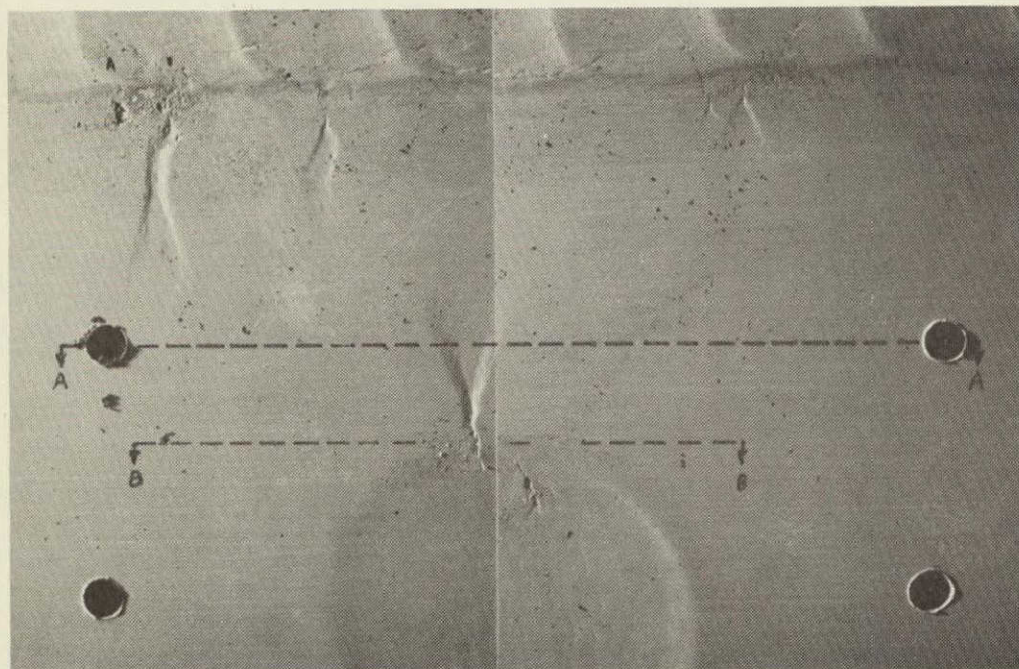
SEM PHOTOS STA 1090, SPOTWELD 42

Figure 2-33. Inside Surface Appearance of a Leaky Vertical Defect Associated with the Same Spotweld Shown in Figure 2-31, and the Location of Two Metallographic Sections (see Figures 2-34 and 2-35)  
S.E.M. Photos

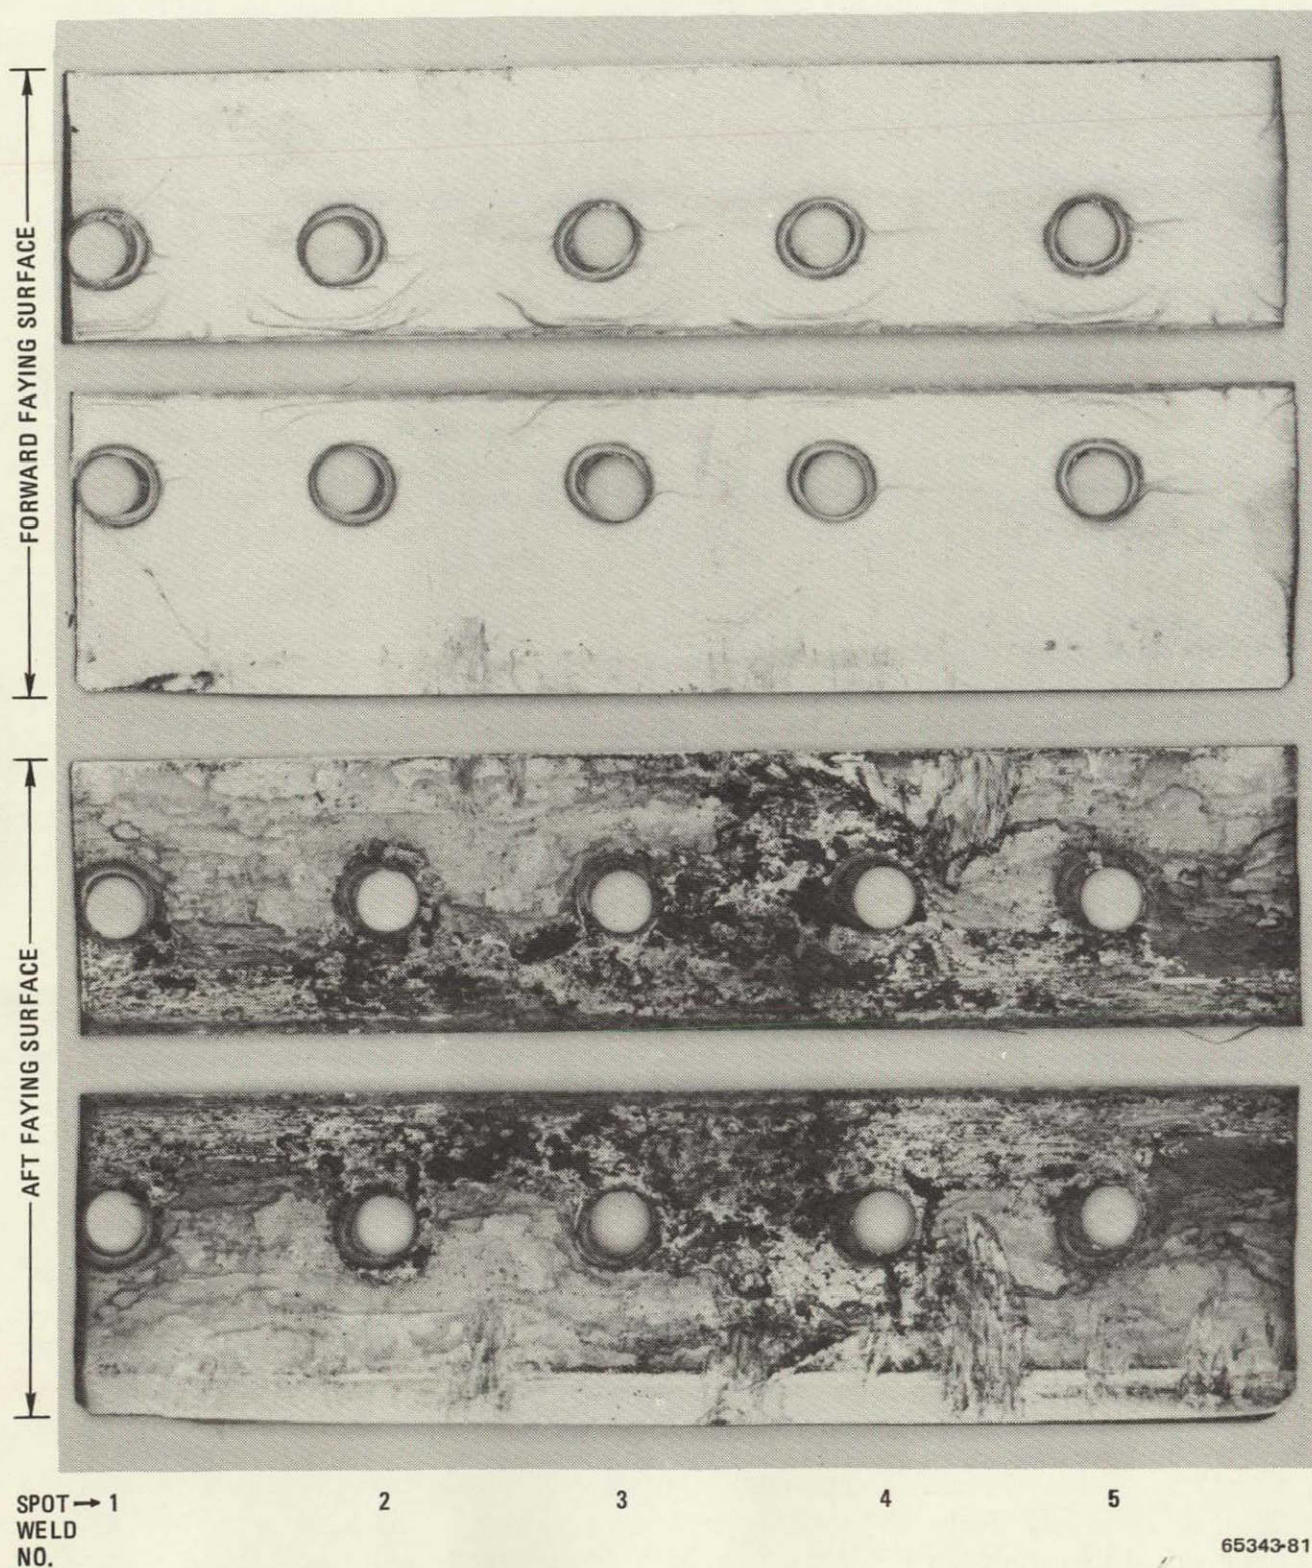
Figure 2-40. Appearance of Opened-up Aft and Forward Faying Surfaces

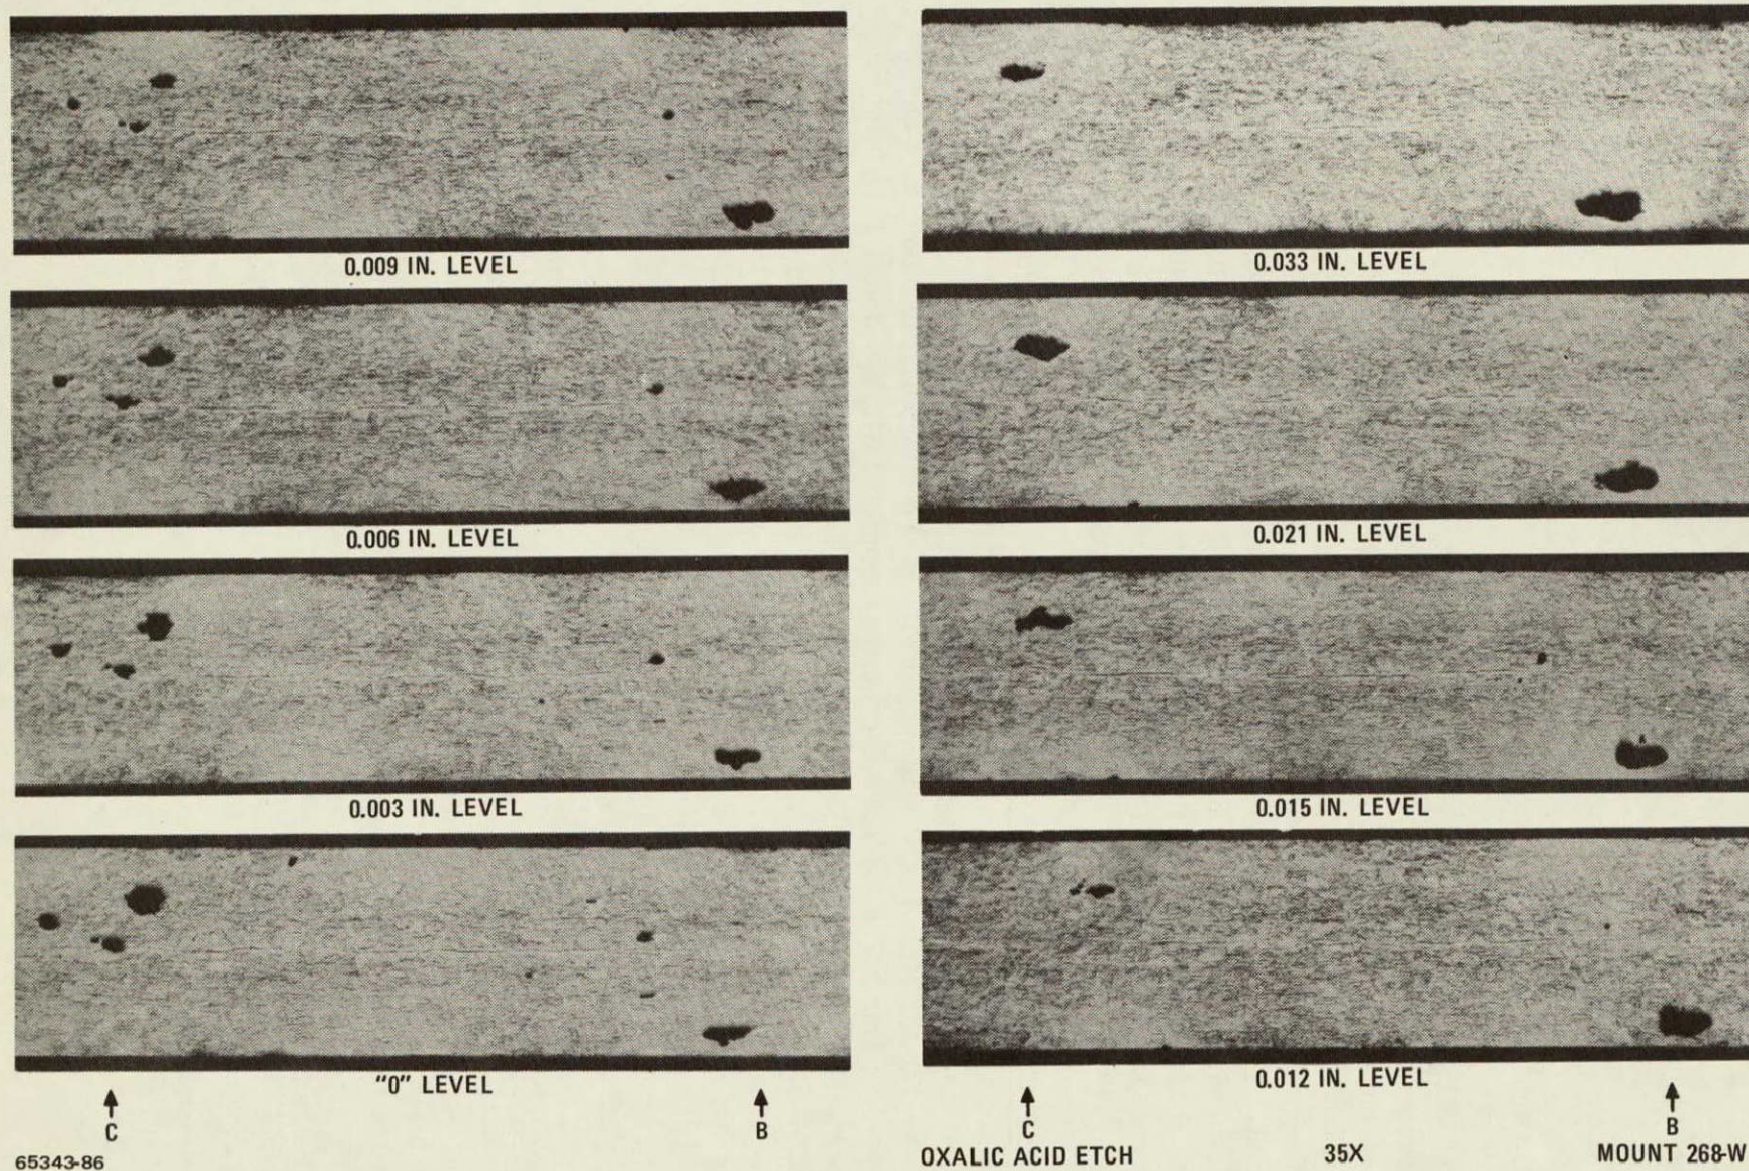
Figure 2-45. Appearance of Defects C and B at Nine Different Section Levels

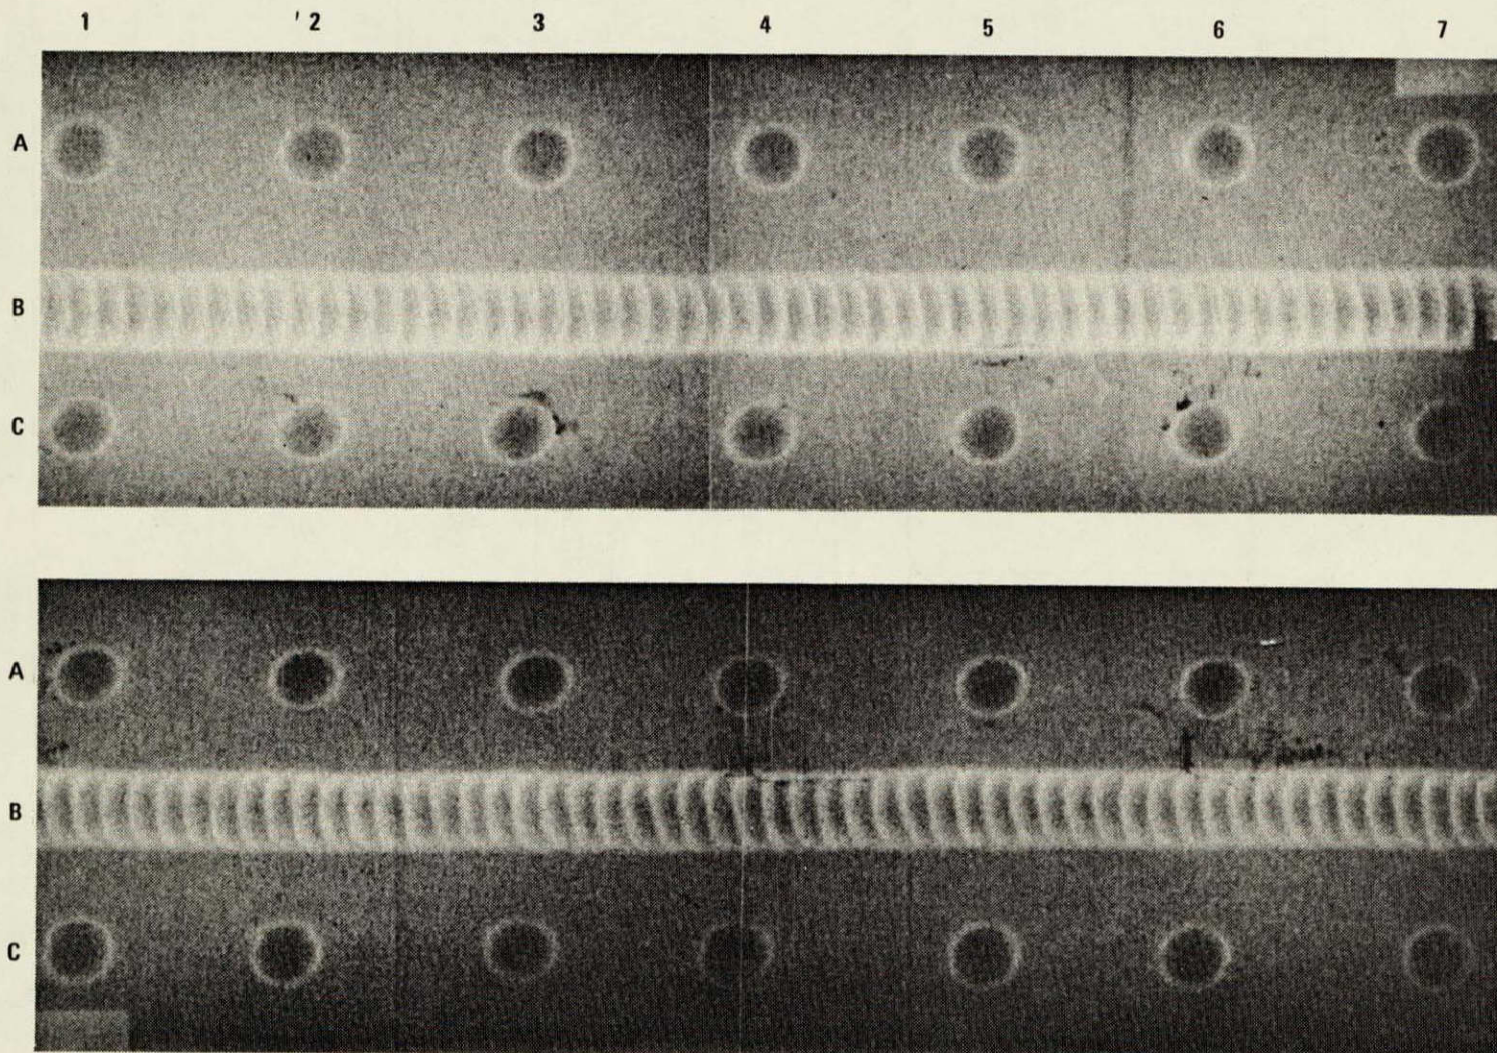
65343-5

Figure 4-4. Radiograph of Typical Defects
